Rimkus Consulting Group, Inc.
Eight Greenway Plaza, Suite 500
Houston, TX 77046
(800) 580-3228 Telephone
(713) 623-4357 Facsimile

Re: RCG File No: 11009971
LLV Number: 0209452
VMF Location: 1530 Greensmark Drive in Houston, Texas
Subject: Final Report

Rimkus Consulting Group, Inc. was retained to examine LLV 0209452, VIN 1GBCS10E4M2908832. The fire occurred on June 13, 2016 at around 12:30 P.M. the operator of the vehicle at the time of the fire, was unavailable for interview but reportedly stated the vehicle's engine died while delivering mail on his route and backfired during subsequent attempts to restart it. Soon thereafter, smoke was observed from beneath the hood as well as flames.

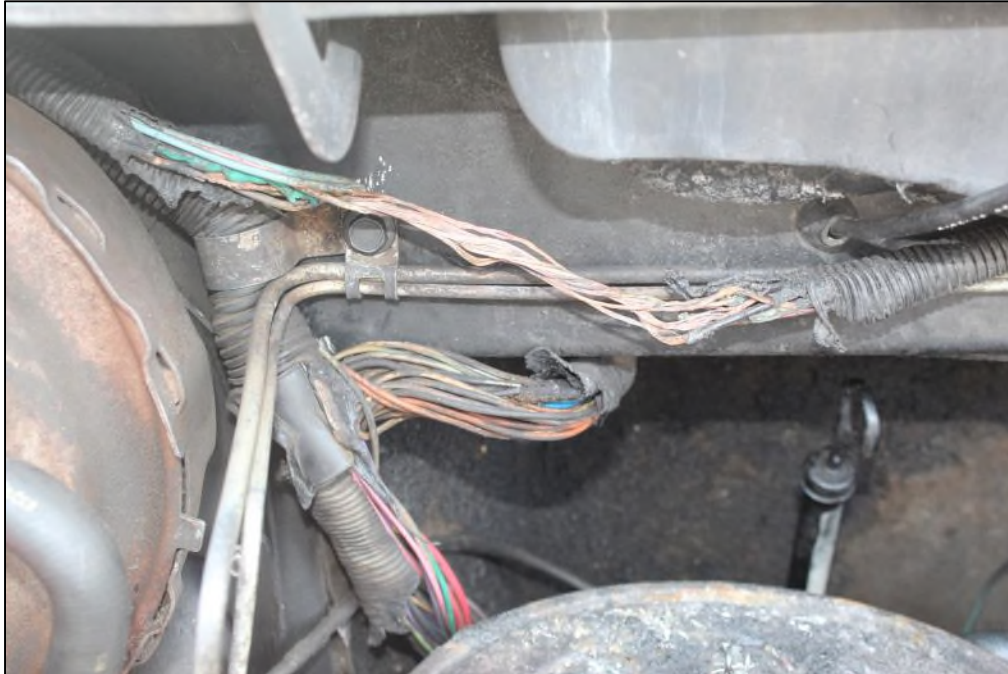
Photograph 7

Fire damage to the wiring harnesses at the upper portion of the bulkhead.

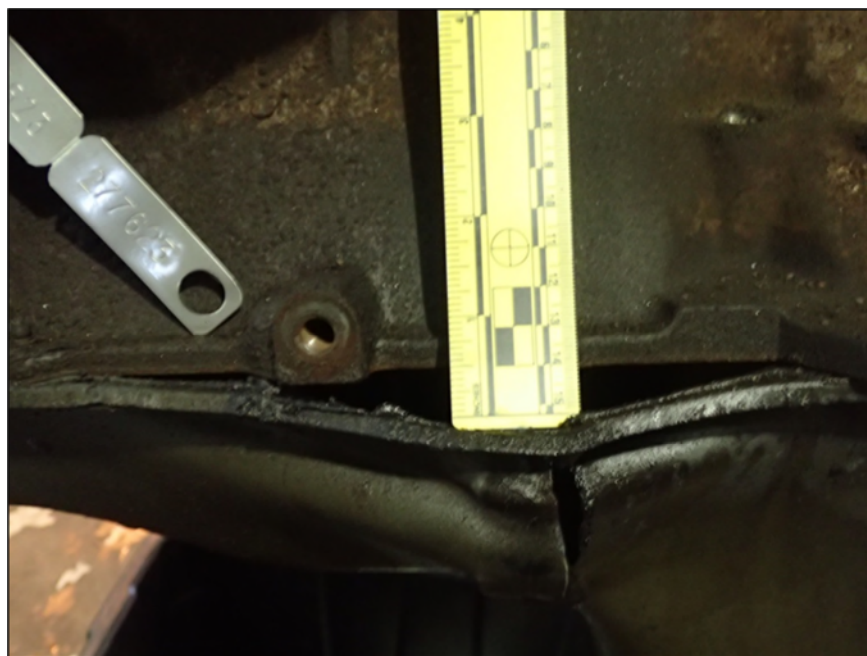
Photograph 4

Separation from engine block.

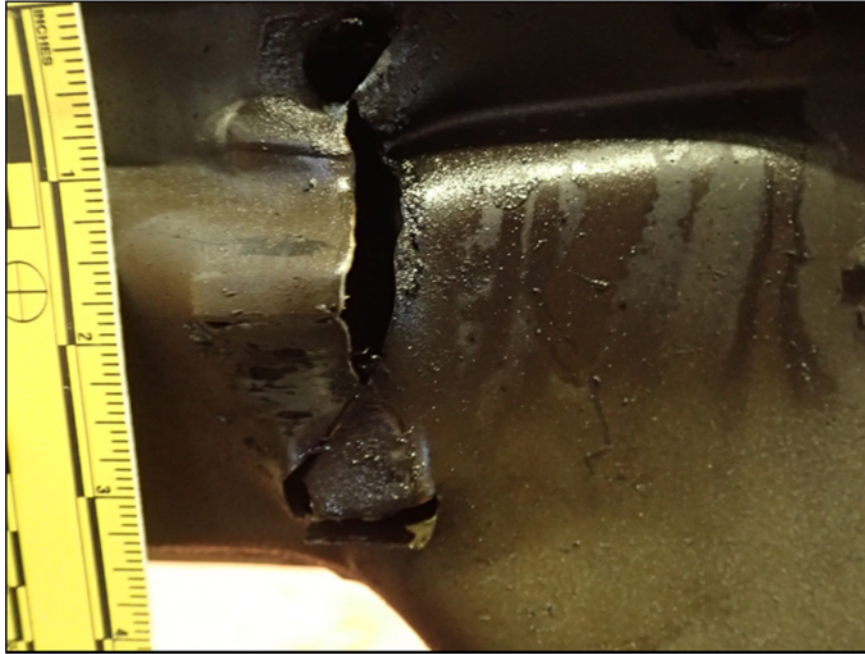
Photograph 5

Tear in the oil pan from internal mechanical failure.

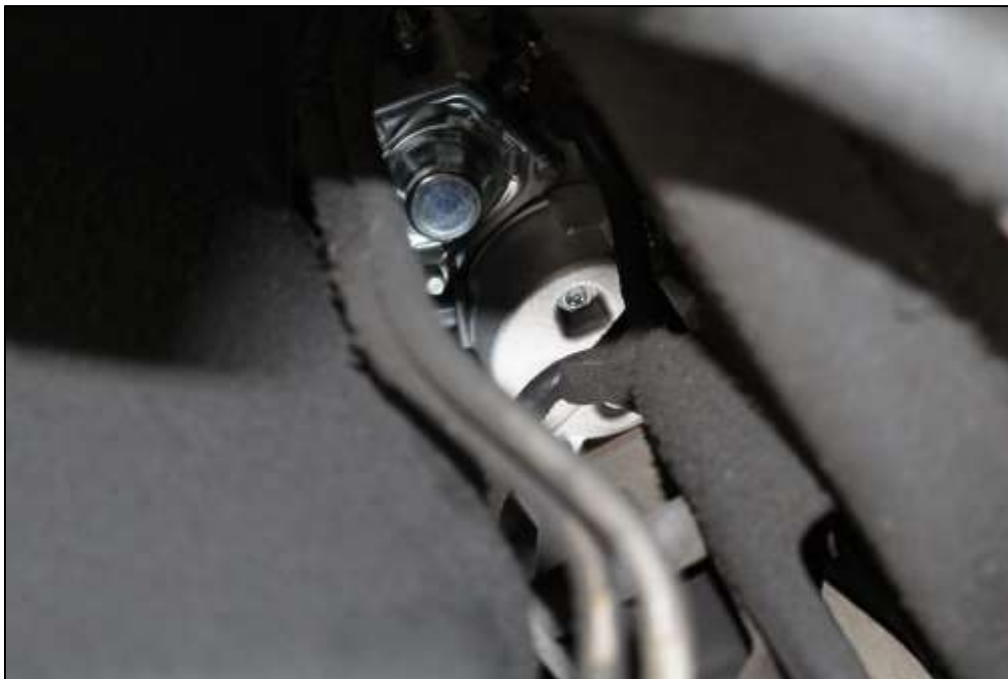
Photograph 6

Looking west and downward; new starter installed several days before fire.

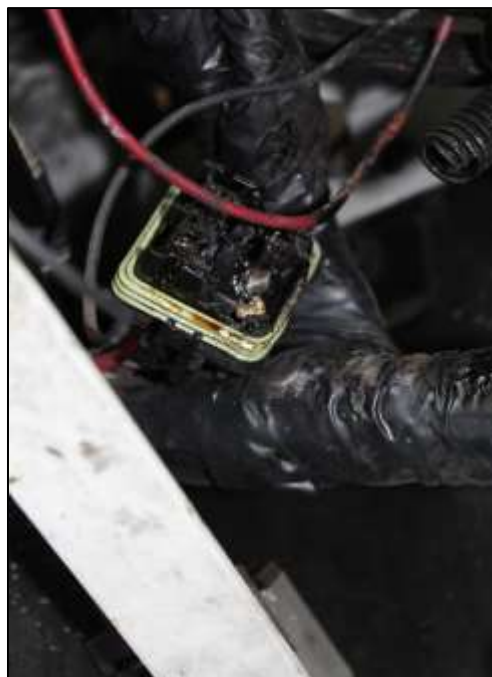
Photograph 10

Looking into dashboard, showing damaged starter relay module and wire.

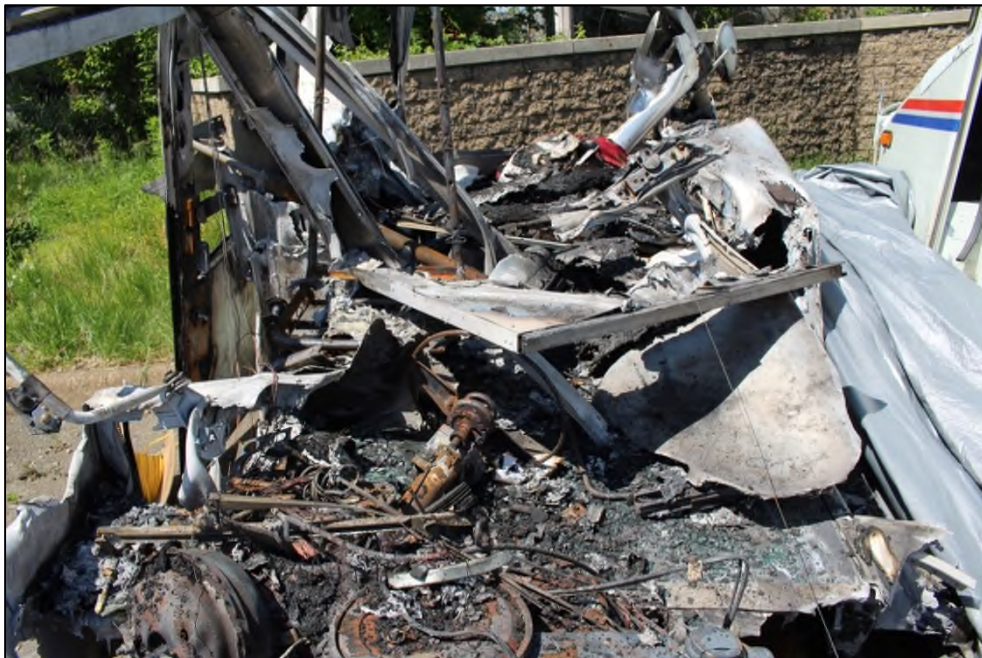
Photograph 6

View of the dash area.

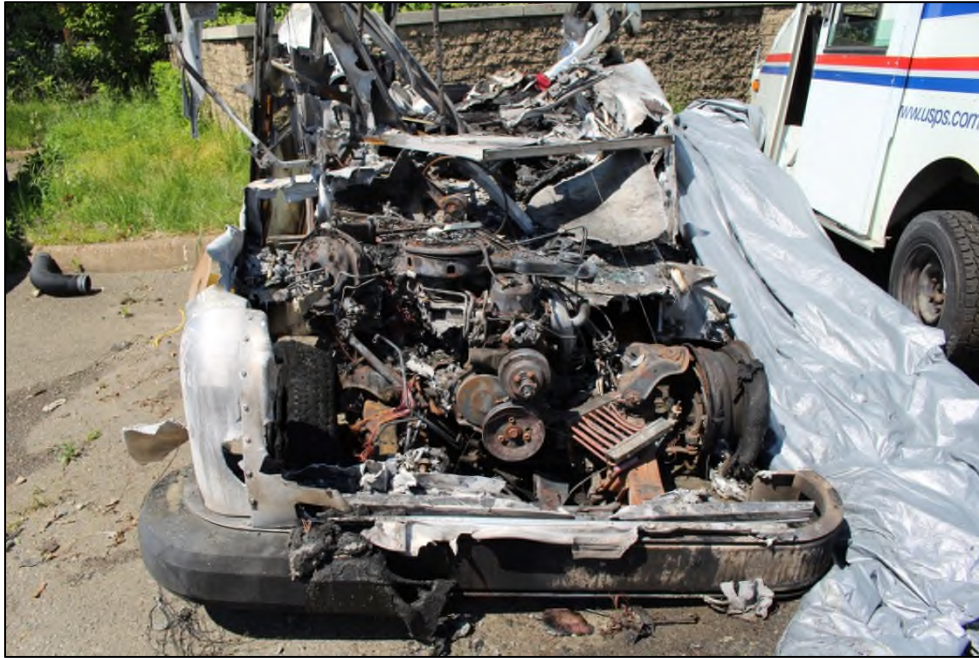
Photograph 7
View of the engine.

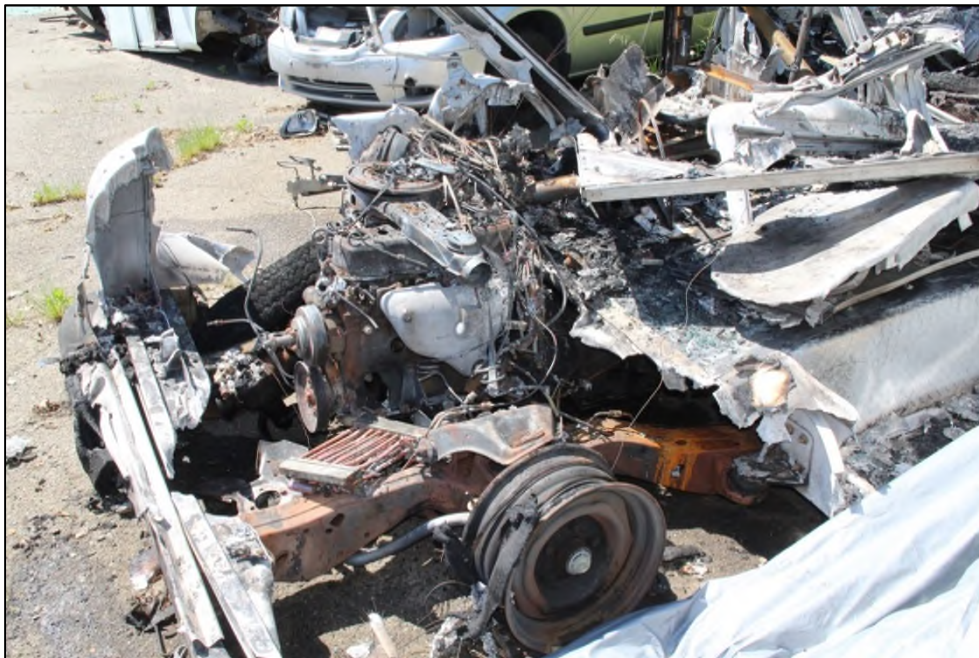
Photograph 8
View of the oxidation on the frame on the mail side of the vehicle.

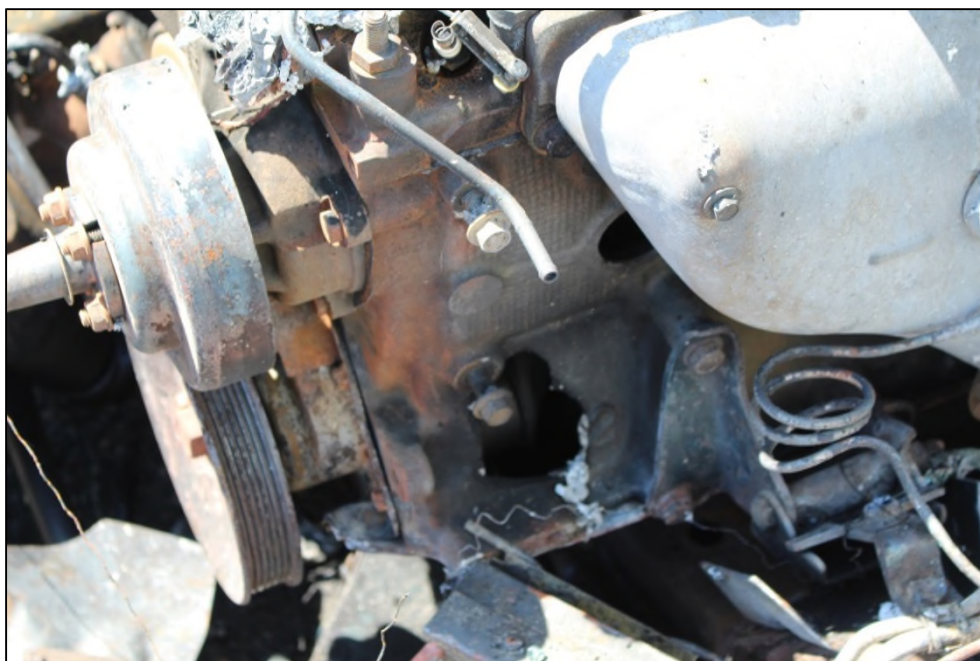
Photograph 9

View of hole in engine block.

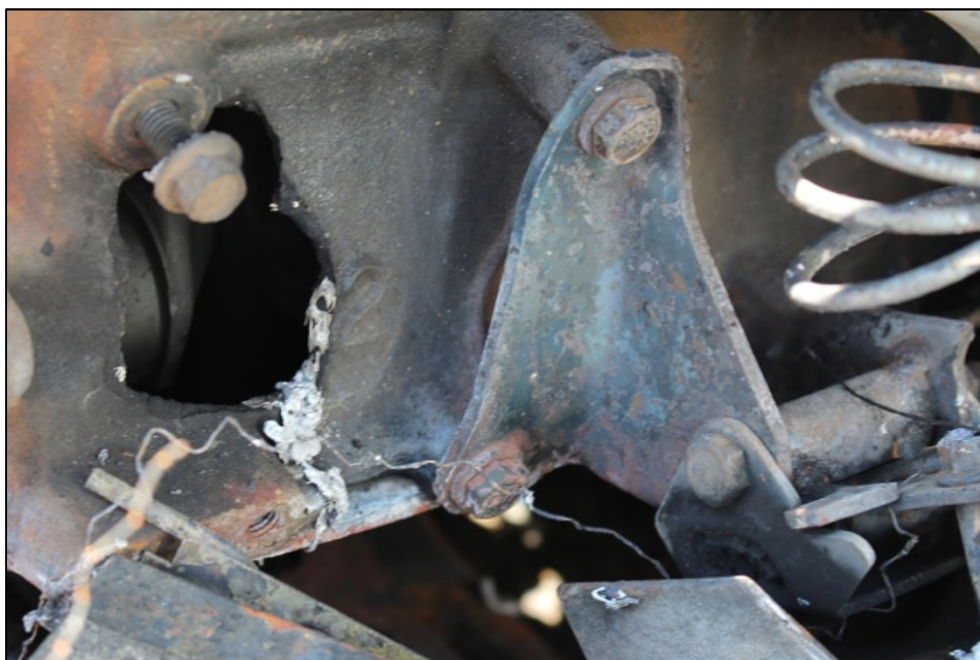
Photograph 10

Close-up view of the hole in the engine block.

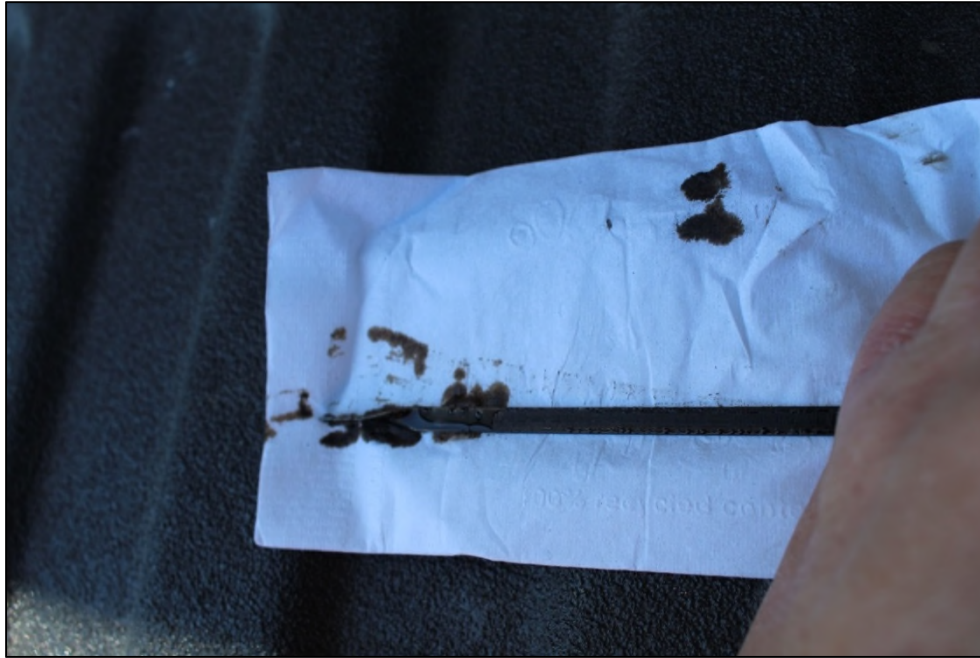
Photograph 11

View of oil level on dip stick.

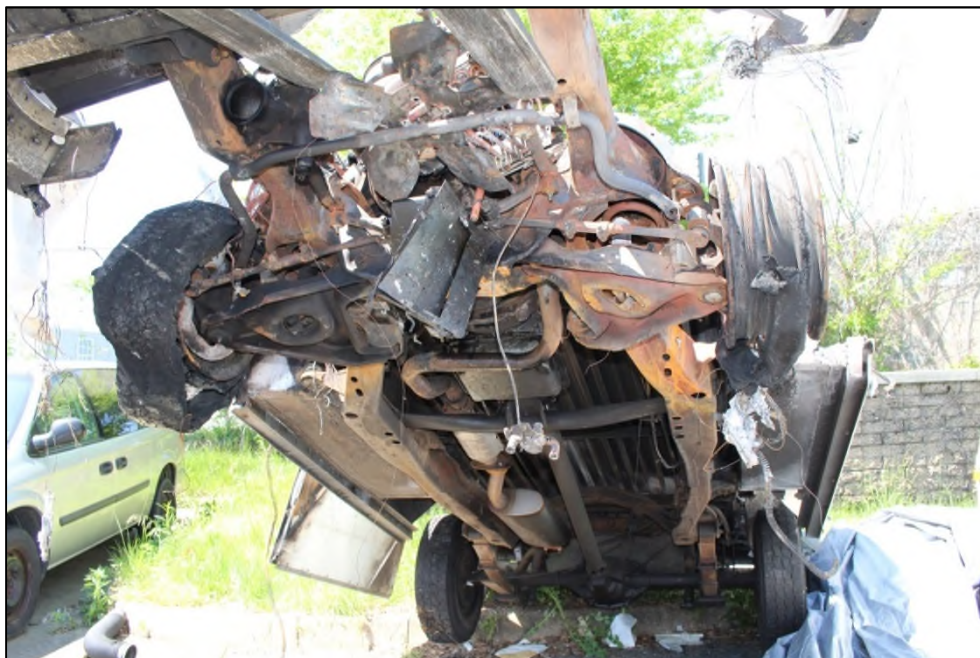
Photograph 12

View of the undercarriage of the vehicle.

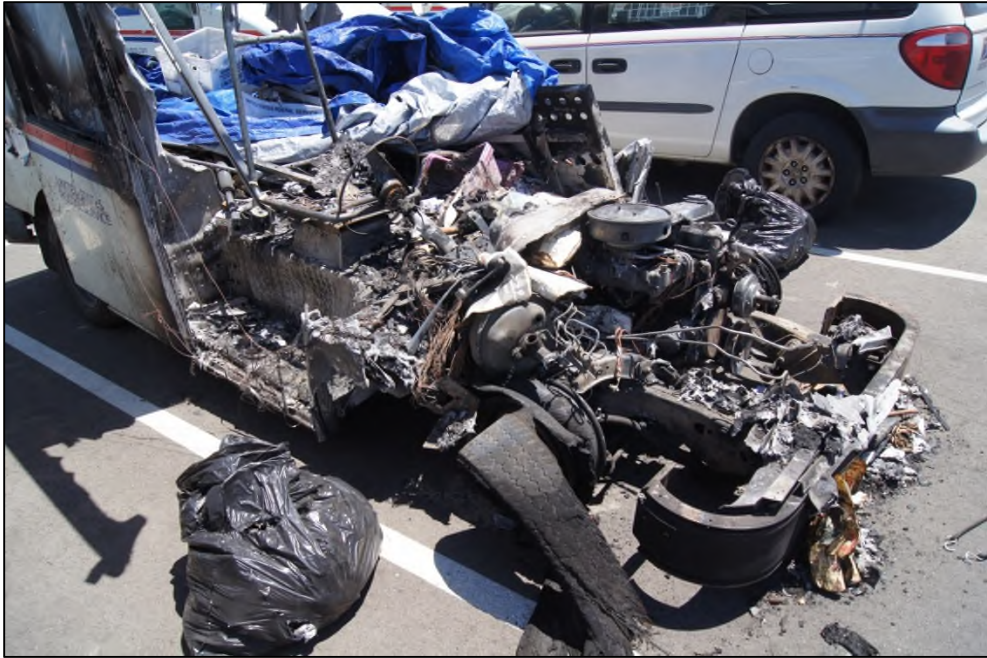
Photograph 1
Right side of LLV.

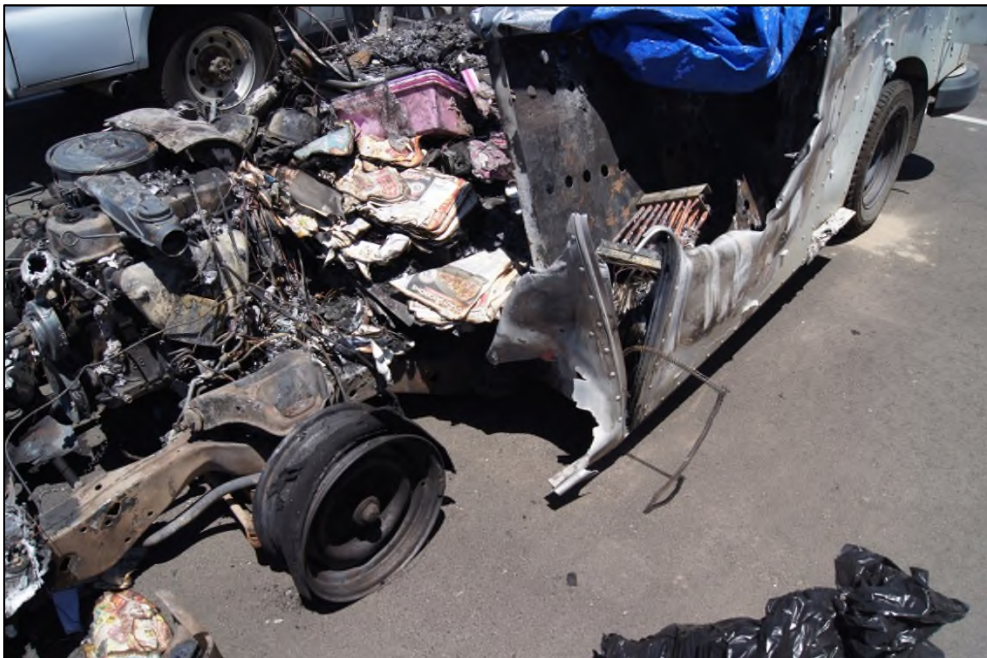
Photograph 2
Left side of LLV.

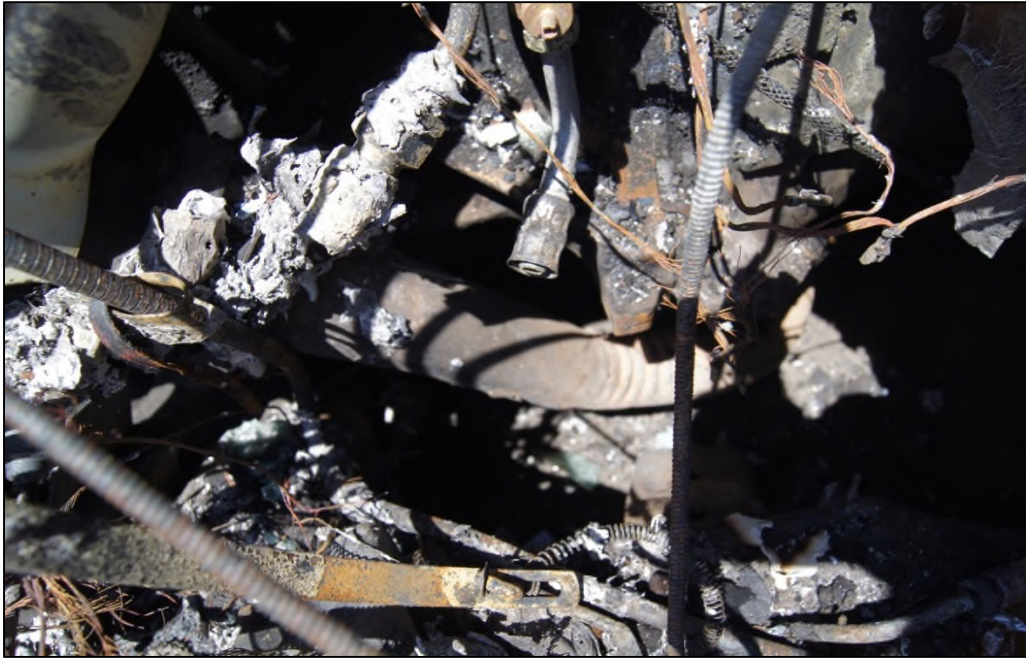
Photograph 3
Fuel lines at engine.

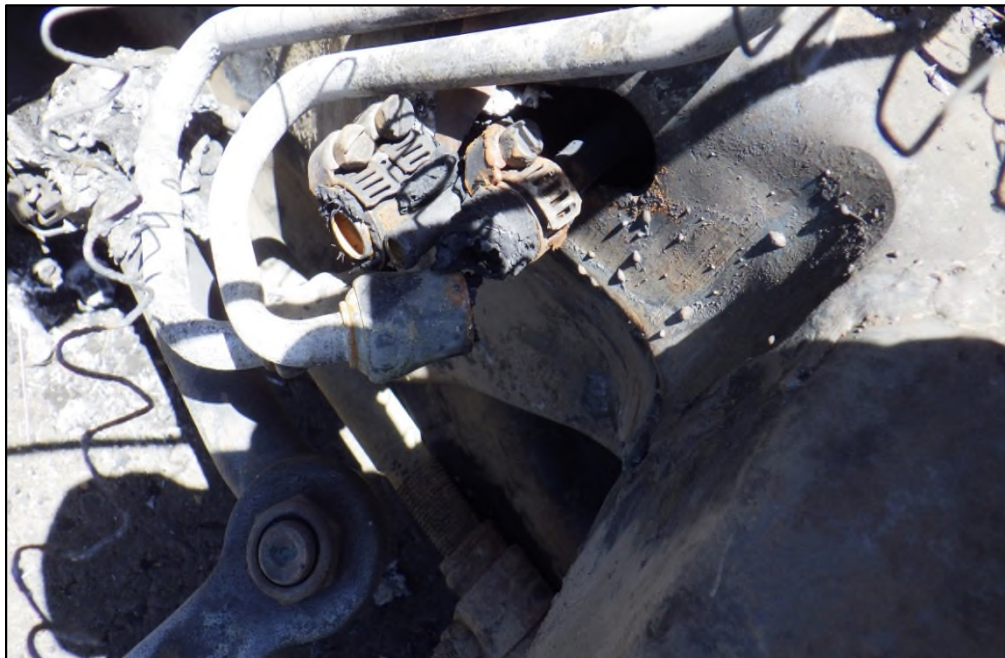
The exhaust system was undamaged by the fire. The rear wheels, brakes, brake lines and tires were undamaged. The rear axle was not leaking or damaged. The transmission was undamaged. The fuel lines were intact along the left frame. The flexible fuel lines at the cross over to the right side above the transmission had sustained severe fire damage.

Photograph 4
Fuel lines from frame to engine.

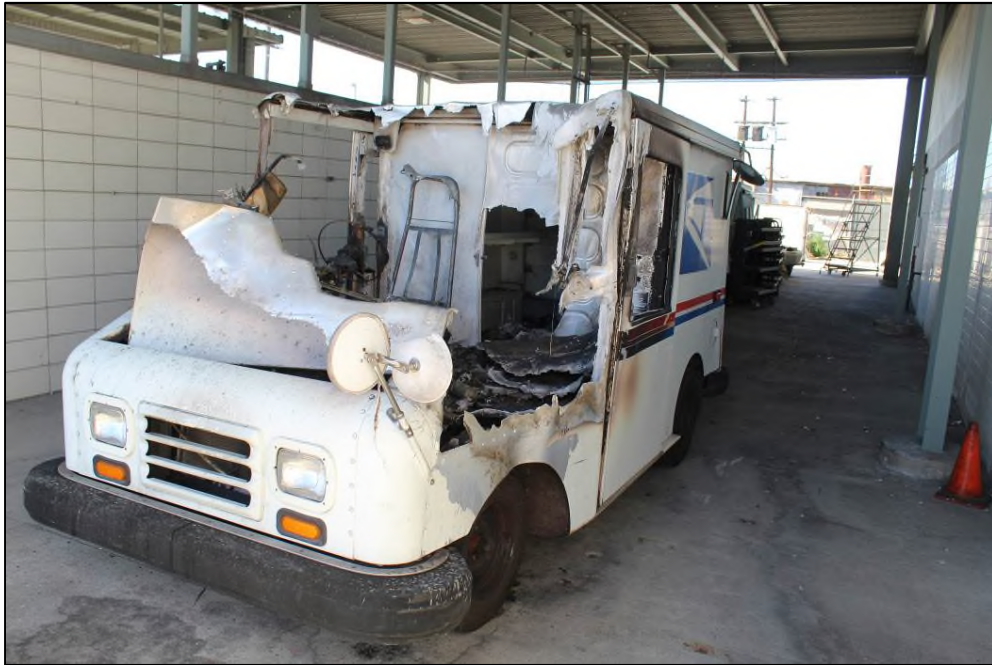
Photograph 1
Subject LLV.

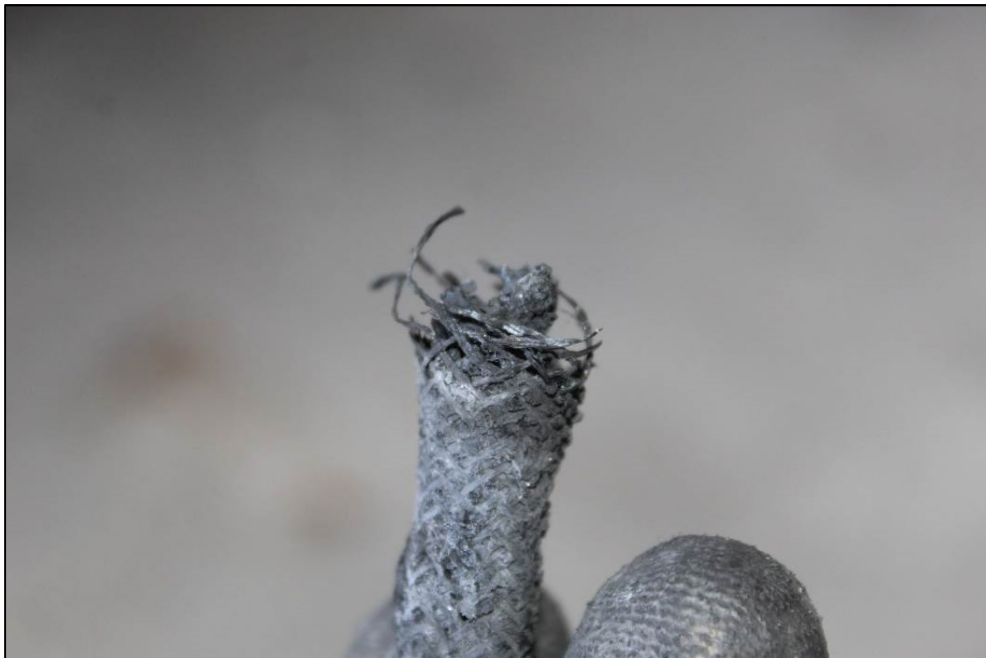
Photograph 4

The high pressure fuel line section from origin area indicated pressurized failure.

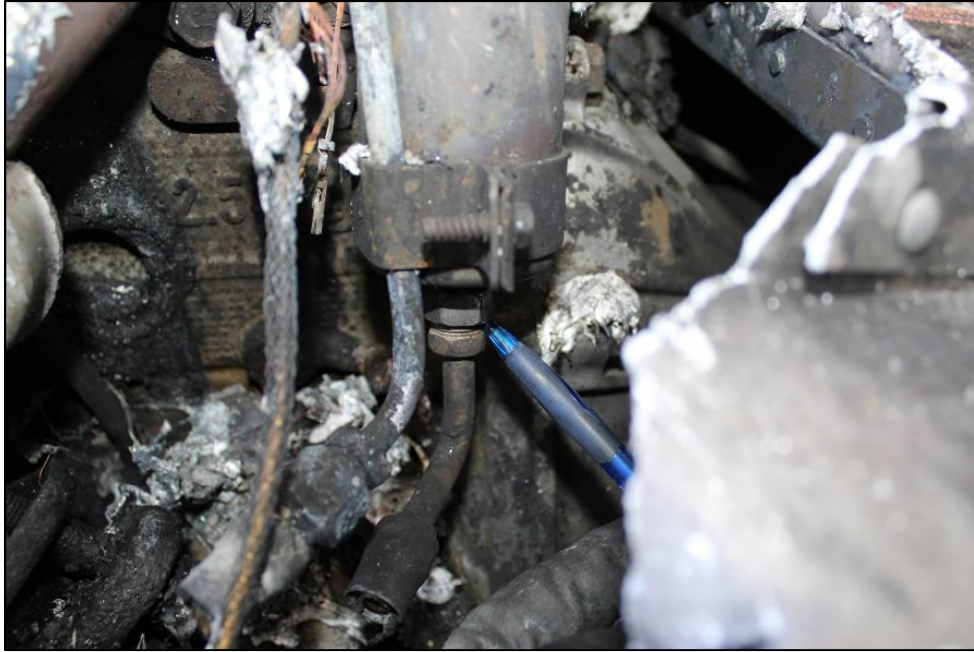
Photograph 5

Fuel filter top, center. Pen indicates location of loose high-pressure connection.

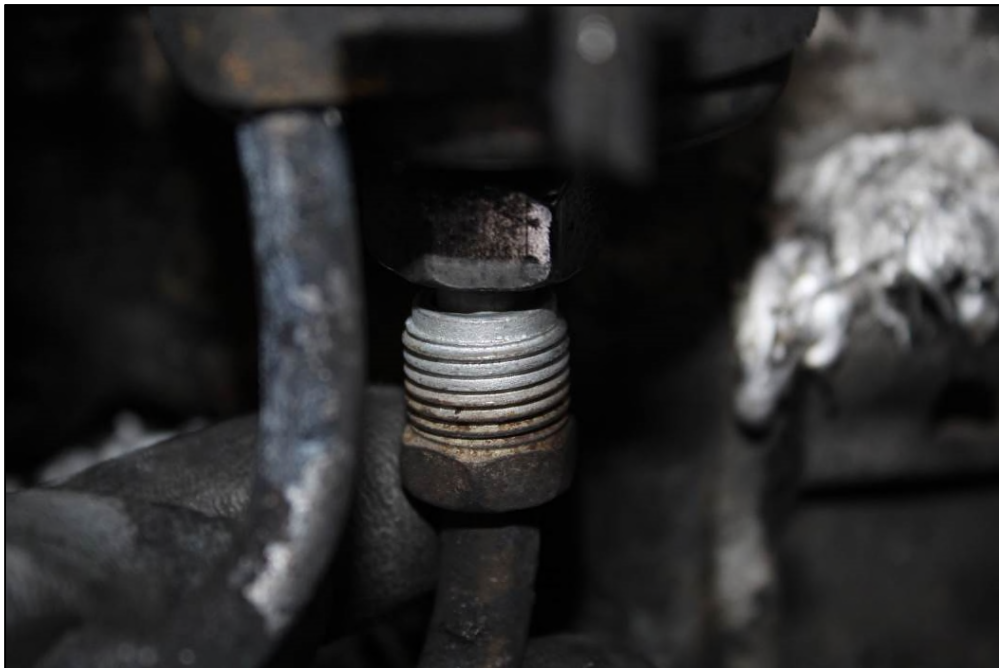
Photograph 6

High-pressure connection easily disconnected by hand.

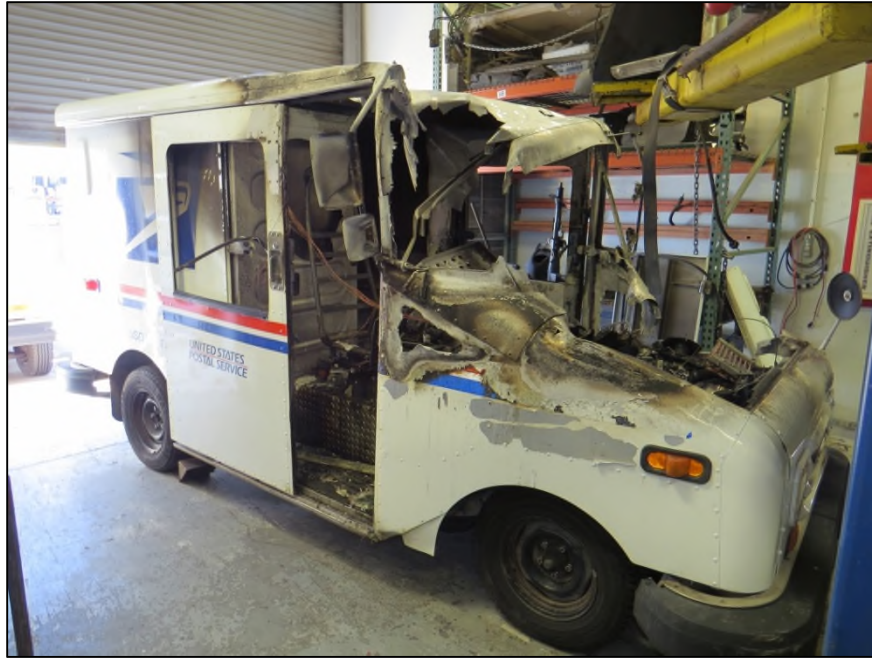
Photograph 1
USPS LLV 2216211.

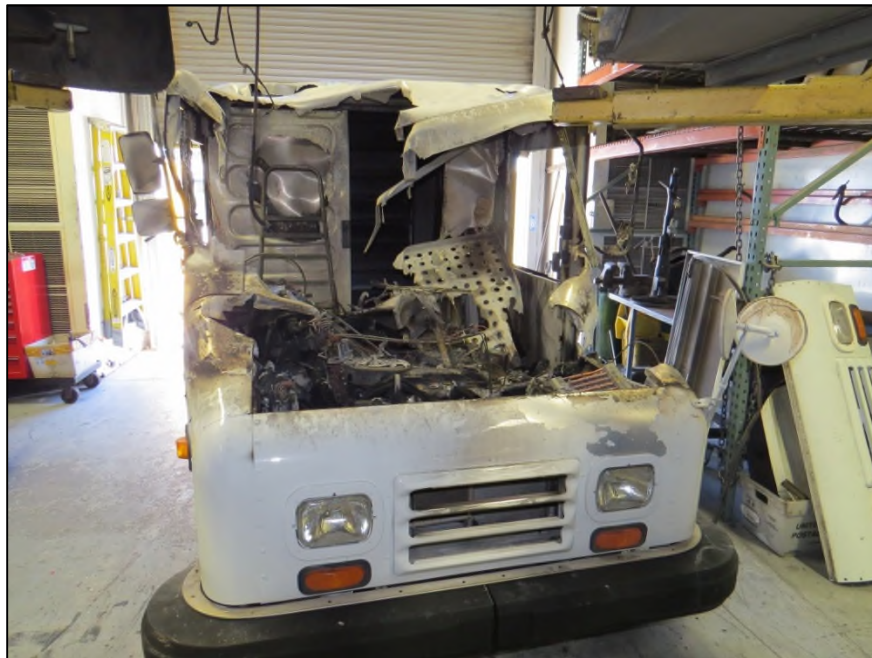
Photograph 2
Front of the vehicle.

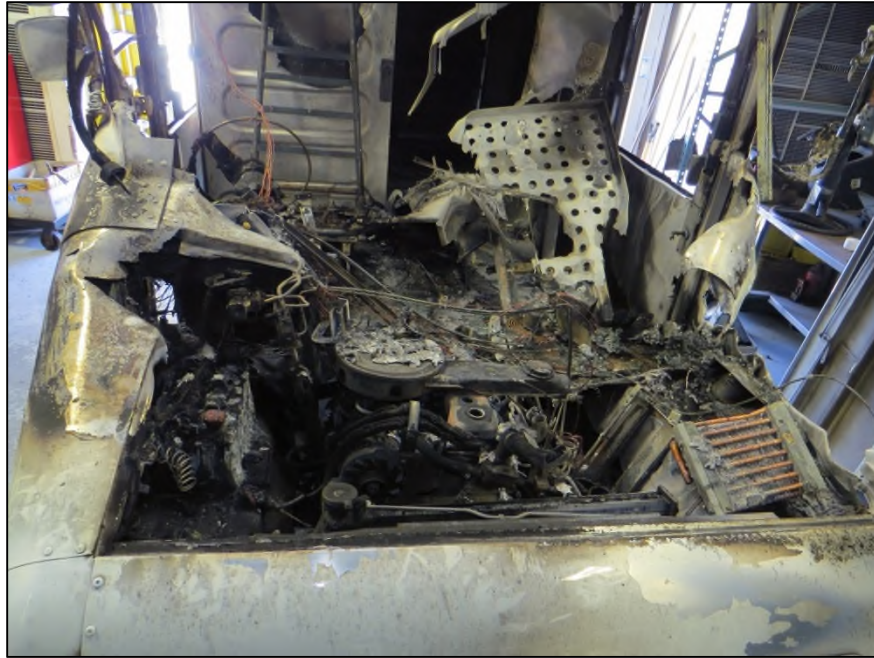
Photograph 3
Engine compartment.

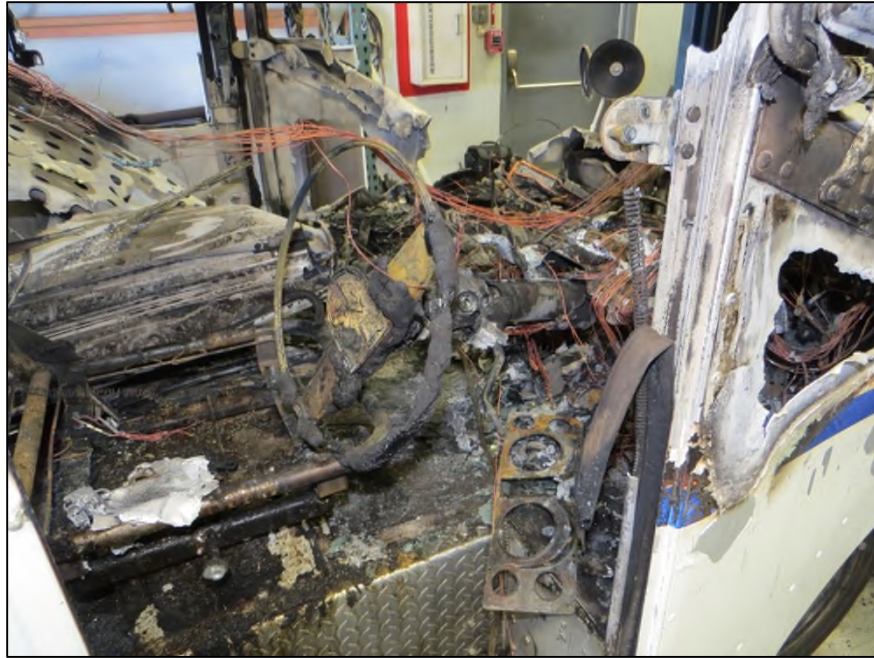
Photograph 5

Interior area, fire progressed from the mail side of the engine compartment.

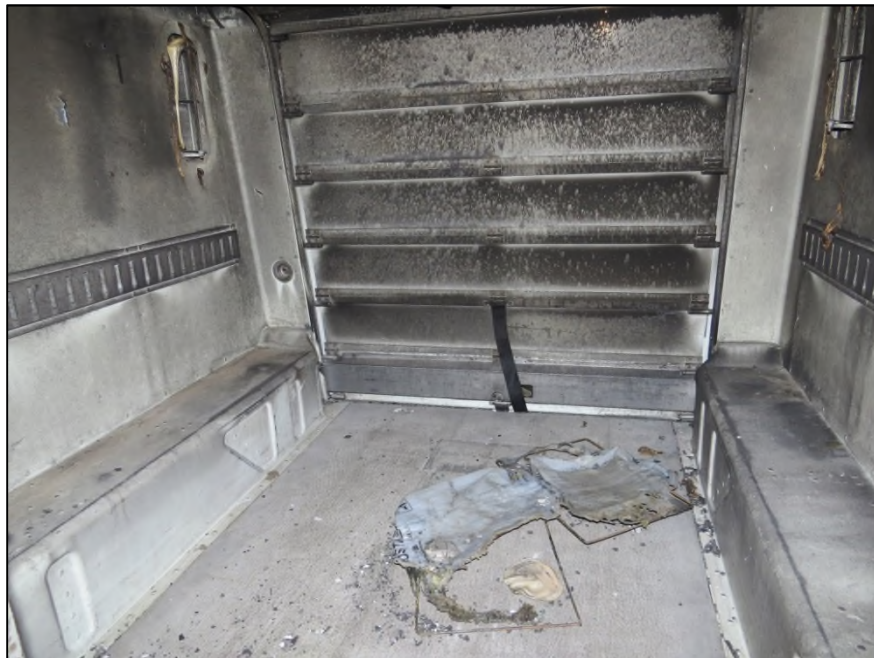
Photograph 6

View of cargo area.

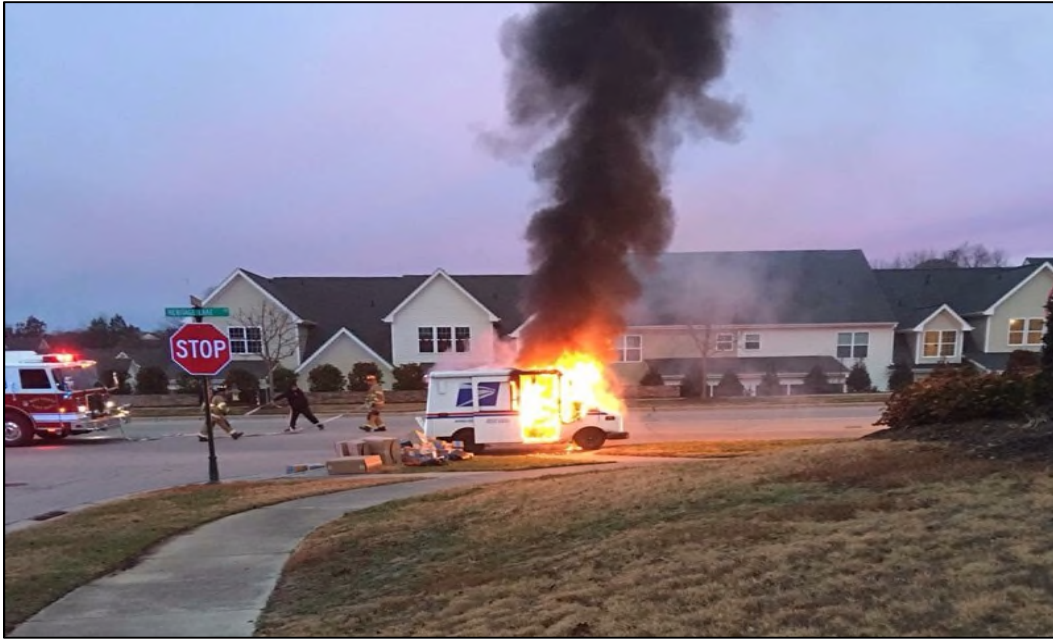
Photograph 1

The LLV fire on December 13, 2016 (Photo provided by USPS).

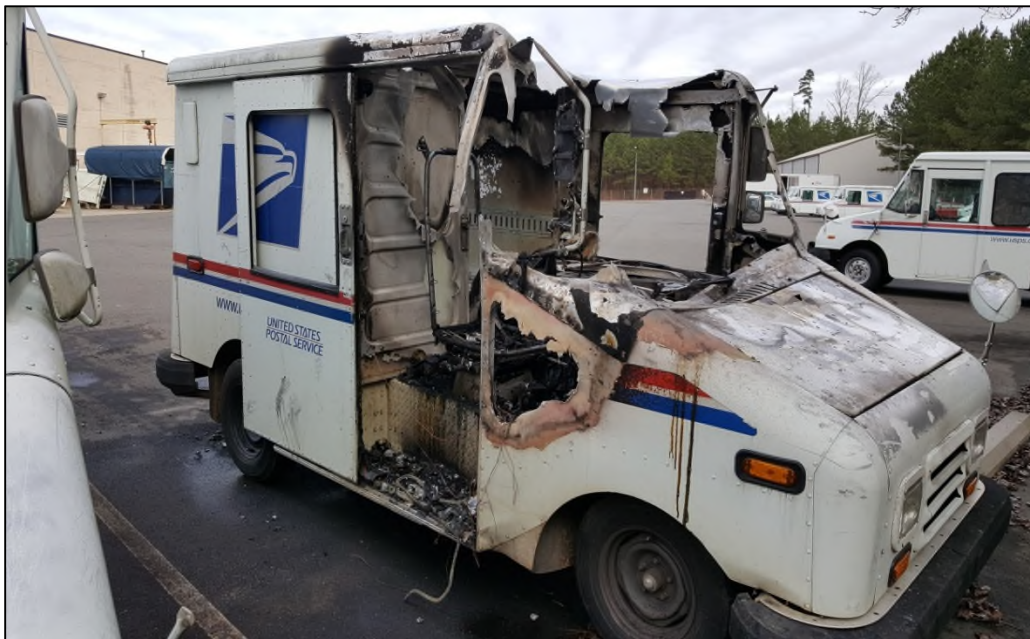
Photograph 2

LLV 2216633, VIN 1GBCS10A8P2904607.

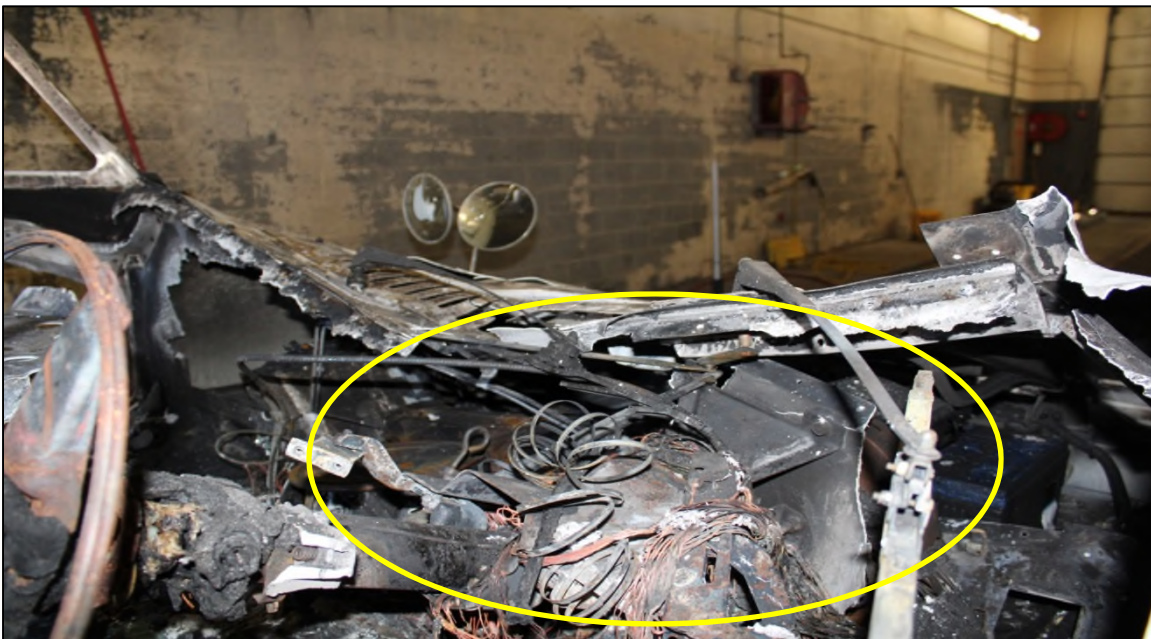
Photograph 8

The area of the dashboard that the headlights switch assembly was mounted.

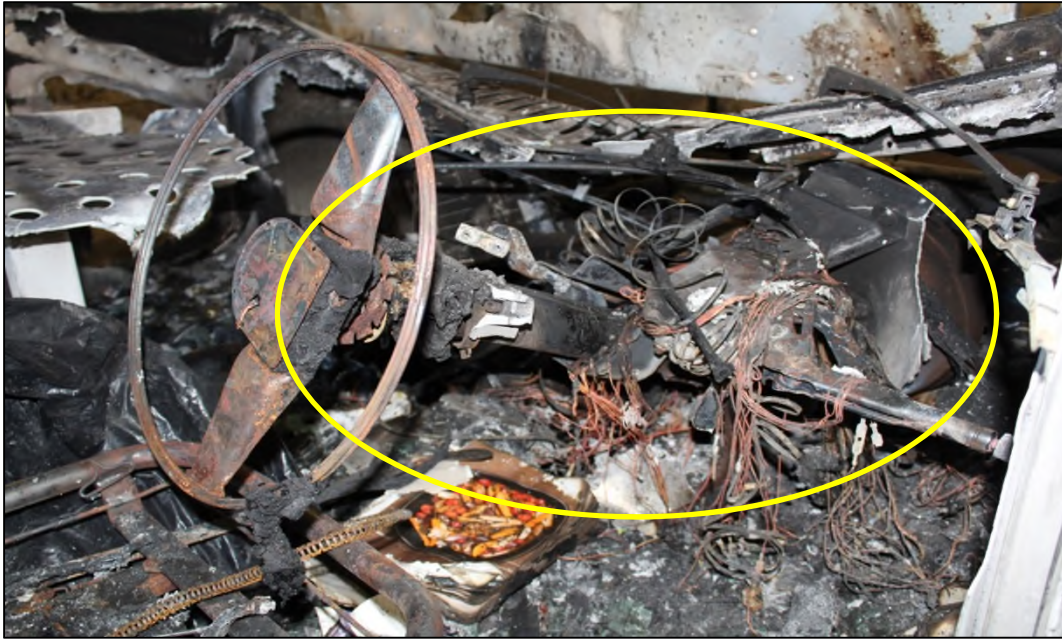
Photograph 9

Observe the area of the dashboard that the headlights switch assembly was mounted.

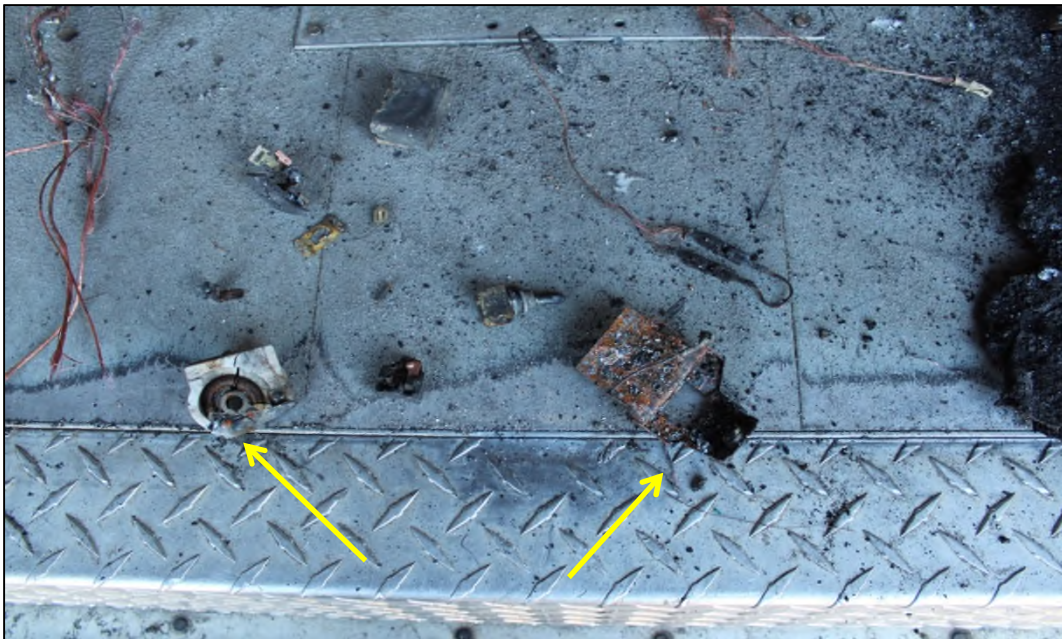
Photograph 10

The headlights switch assembly pieces remaining; observe the severe fire damage to the mount and the switch assembly.

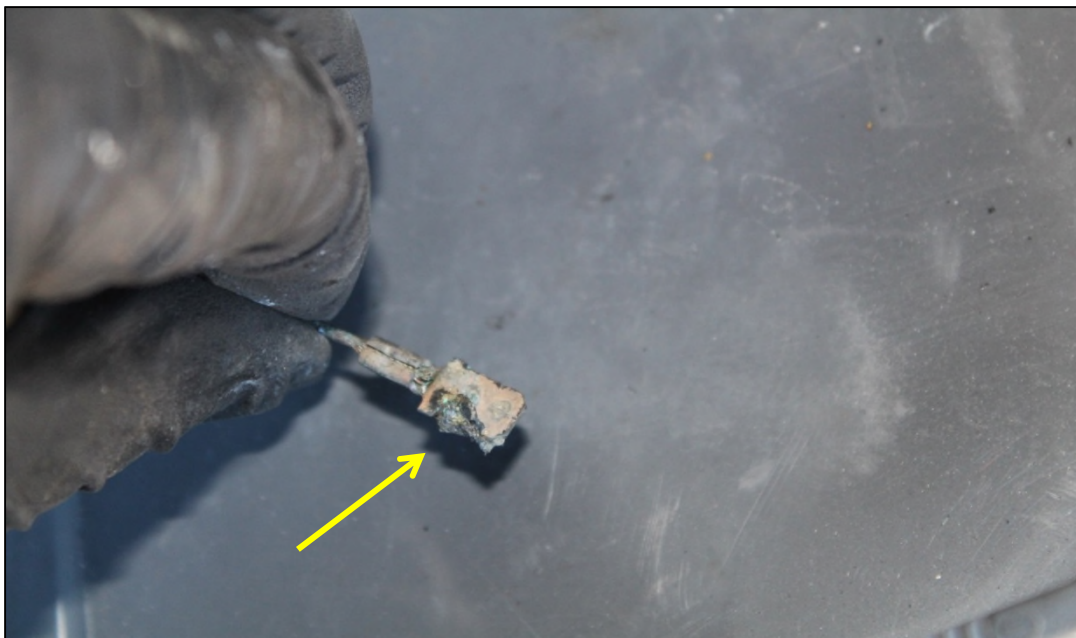
Photograph 12

Observe the adverse electrical activity on the terminal end for the headlight switch.

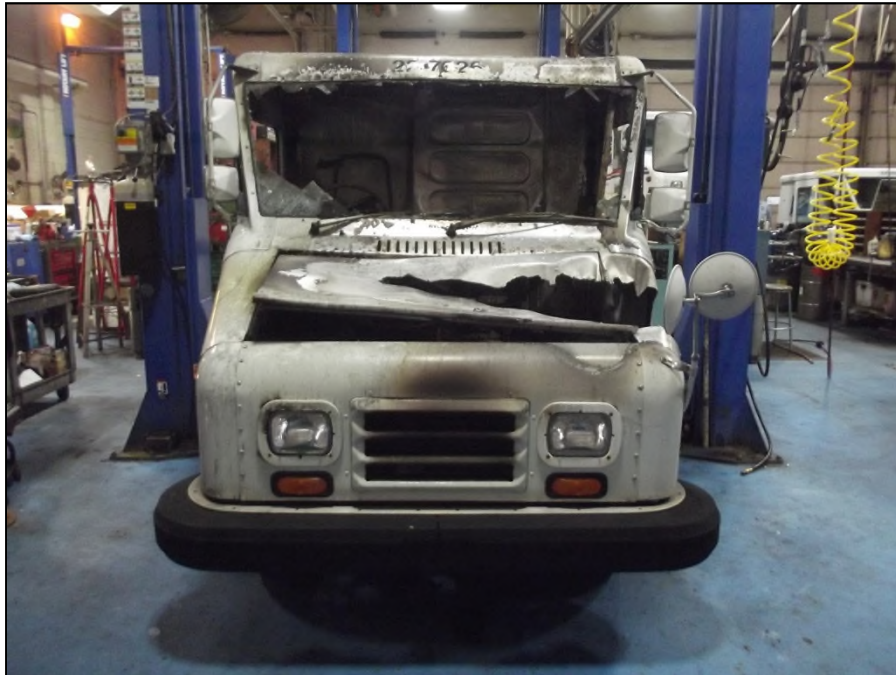
Photograph 1
Front of the vehicle.

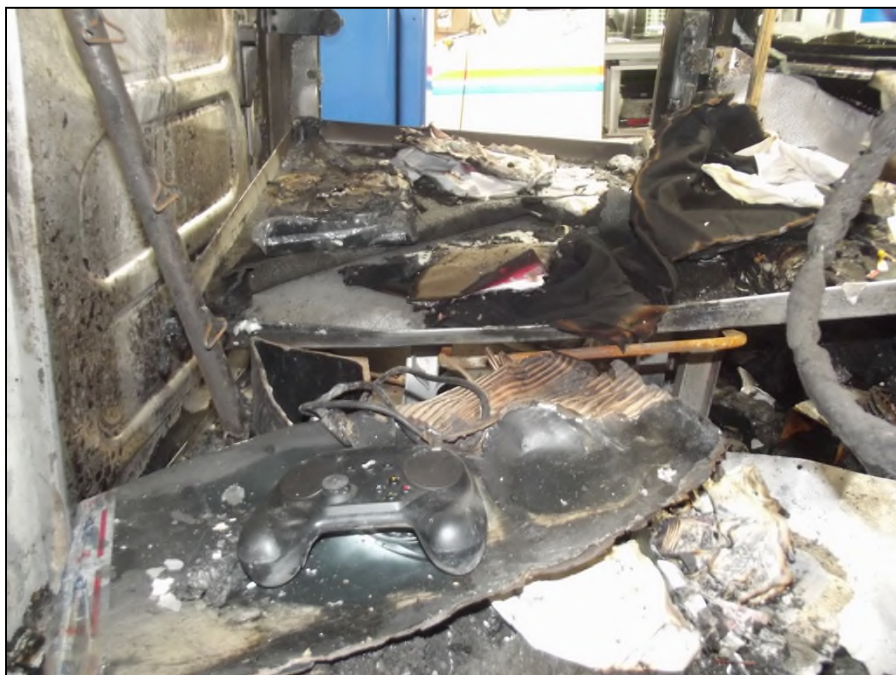
Photograph 2
Driver's compartment.

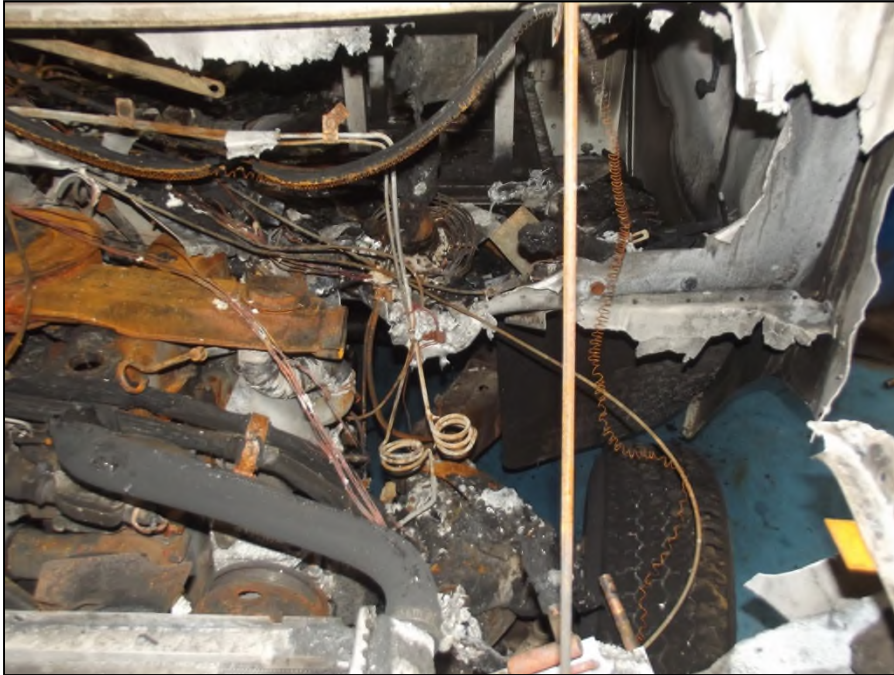
Photograph 3

Top view of area of origin, mail side of engine compartment.

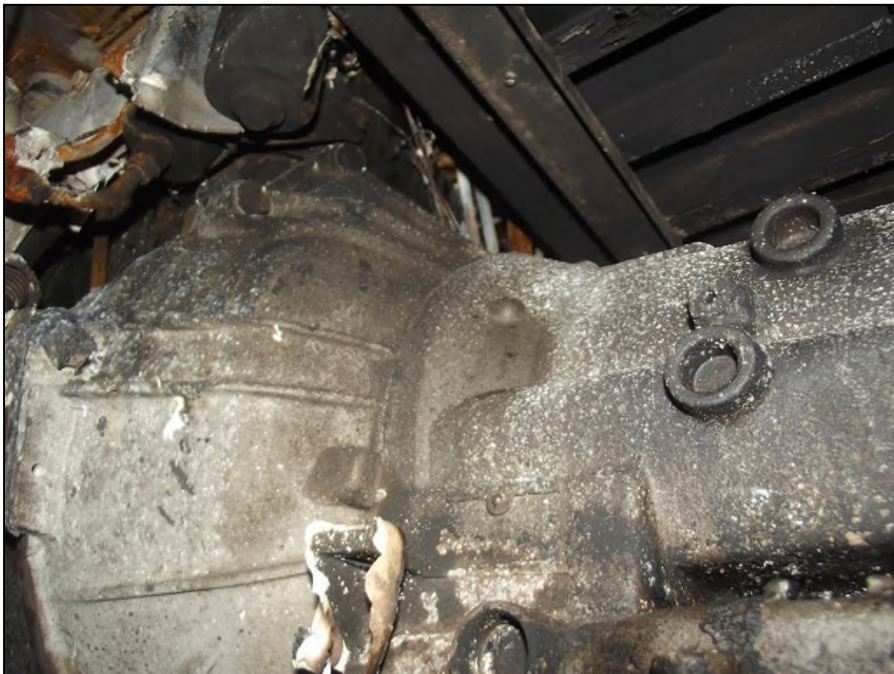
Photograph 4

Transmission housing.
